Darlington Arms Condominiums

Reserve Fund Plan of the Darlington Arms Condominium Corporation

Reserve Fund Report

Revised September 2002

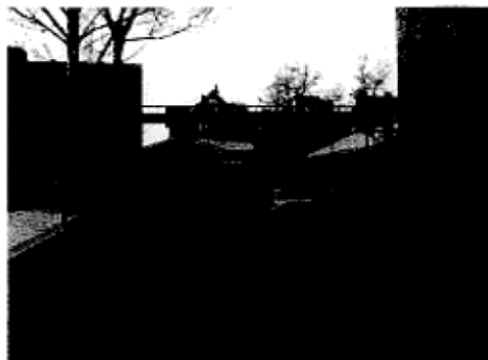
Paving

Surface parking on the south side of the complex is actually on the roof of an extended portion of the underground garage. It is likely, but not confirmable without destructive testing, that the concrete slab is protected by a bituminous membrane below the asphalt surface. Any repair of the asphalt must be done with this in mind. A yearly crack filling program will help to protect both asphalt and membrane.

The surface comprises **some 5,300 sq. ft.** and was likely redone at the time of conversion of the building to condominium in 1998. No signs of leakage were noted on the underside of the slab and with maintenance, the surface should last another **16 years** on a **20 year cycle**. Cost to put a top lift on the pavement should be about **\$8,000**, but if work is required on the membrane this cost could triple very quickly. Budget **\$16,000** for surfacing and partial membrane replacement in **year 16**.

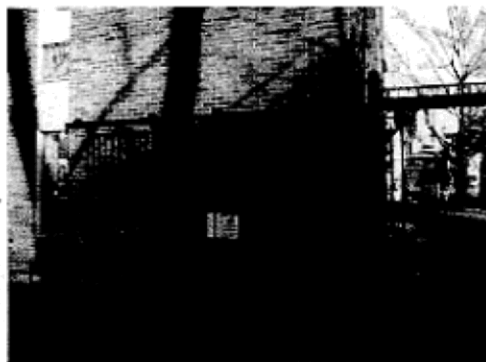
Security Gate

The surface parking area at the south end of the building is secured by a powered sliding steel gate. At the time of field inspection the gate did not appear to be in use, a situation found in several other complexes. The climate in Calgary is not kind to this type of equipment. One device that is said to be helpful is a heater for the actuating mechanism. If there is not one in the unit, they are commercially available. Gates of this sort will cost **\$30,000 and up** to install and should be serviceable for an indefinite time period. Budget **\$1,500** every **6th** year starting in **year 2** for necessary repair. This is not for regular maintenance, as annual maintenance costs are not properly considered reserve items.

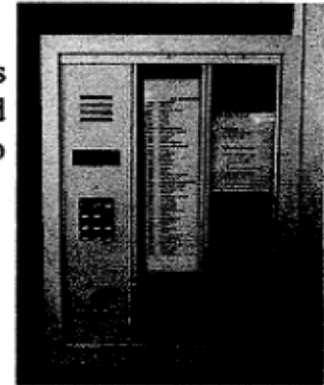
Intercom

A multi-station intercom system is employed to provide guest access through the front entry of the building. It should have a **35 year** life and would currently cost about **\$3,000** to replace. Remaining life is projected to be **7 years**.
