Darlington Arms Condominiums

Reserve Fund Plan

Following up on the reserve fund study by
Morrison Hershfield Engineering, February 2007

4. OBSERVATIONS AND RECOMMENDATIONS

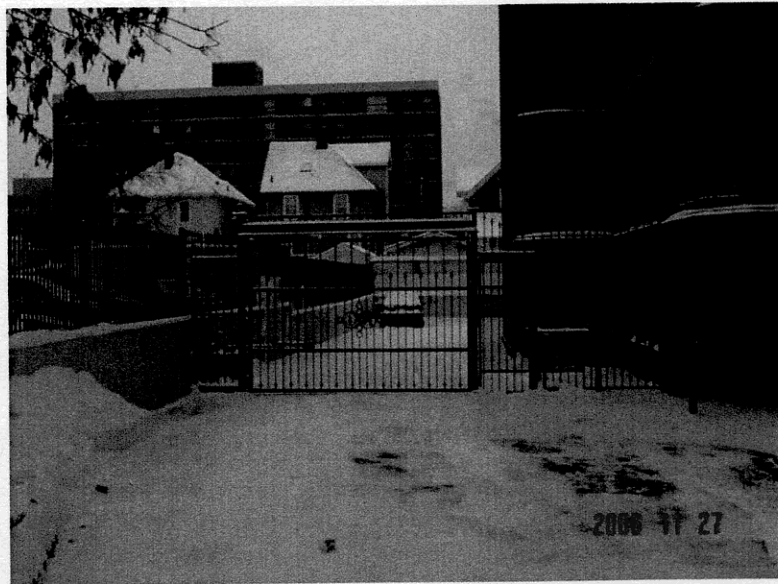
Photo 2: Metal Fence Complete With Automatic Gate.

Painted metal fences (Photo 2) are provided on the east and west sides of the complex. The fences appear to be in good condition. A motorized metal entry gate is provided on the east side driveway entrance of the complex. An entry control system has been provided at the main gate.

Metal fences have an estimated service life of 30 years. An allowance of \$25,000 has been included in the Study for replacement of the metal fences every 30 years starting in 27 years. An additional allowance of \$5,000 has been included to paint the metal fences/metal handrails and minor repairs every ten years starting in seven years. Repairs to the main gate are considered

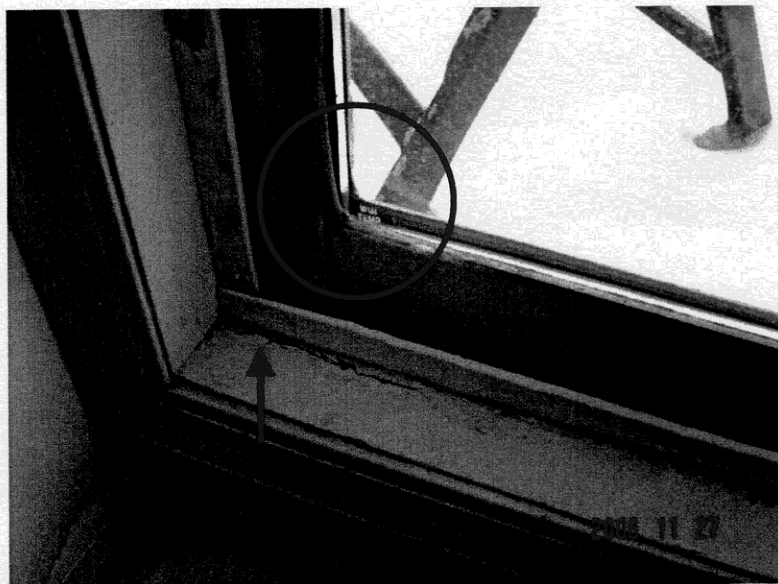
The majority of the windows in the complex are wood framed with aluminum inserts. The windows consist of fixed and slider panes. The windows appeared to be in poor condition and at the time of review, ice build-up and seal damage was noted on units reviewed (Photos 5 and 6).

'Sue; needs painting - owner's job.

Photo 5: Window Wood Damage and Seal Failure.

Aluminum windows with single pane sliding windows were used extensively in the 1970's and early 1980's. These windows do not meet current standards for air and water leakage. It is very difficult to make this style of window air and waterproof, as each pane of glass is allowed to slide and therefore no positive seal can be obtained between the glass and the tracks. The lack of seal allows water entry and air infiltration. The air movement in the winter season contributes to condensation and frosting on the glass surfaces which may lead to deterioration of the surrounding wood framing. An allowance of \$276,000 has been included in the Study to replace windows in two years, phased over four years and every 30 years subsequent.

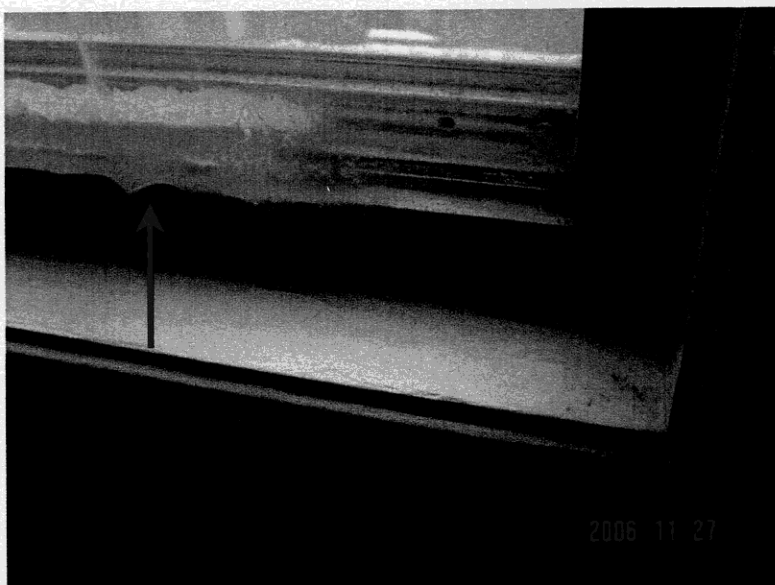
← This suite was running humid - after all winter!

Photo 6: Ice Build Up

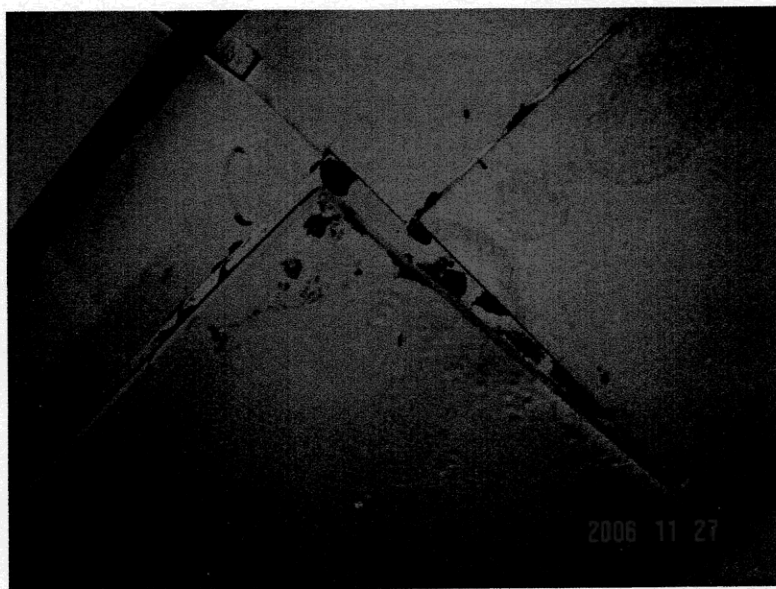
4.10 Interior finishes: The last paragraph on page 15, and the photo above, show boiler room insulation separating from the ceiling. All loose panels of insulation were secured in April, 2007. As well, the sump was cleaned out in 2005, and channels were cut in the boiler room floor to drain away water from flushing of hot water tanks and the heating boilers.

Main mechanical room walls are painted slab in place concrete with an insulated ceiling (Photo 8).

Photo 8: Insulated Mechanical Room Ceiling

The mechanical room ceiling insulation is detaching and should be repaired as soon as possible. An allowance has not been included as these repairs are considered as a maintenance item.

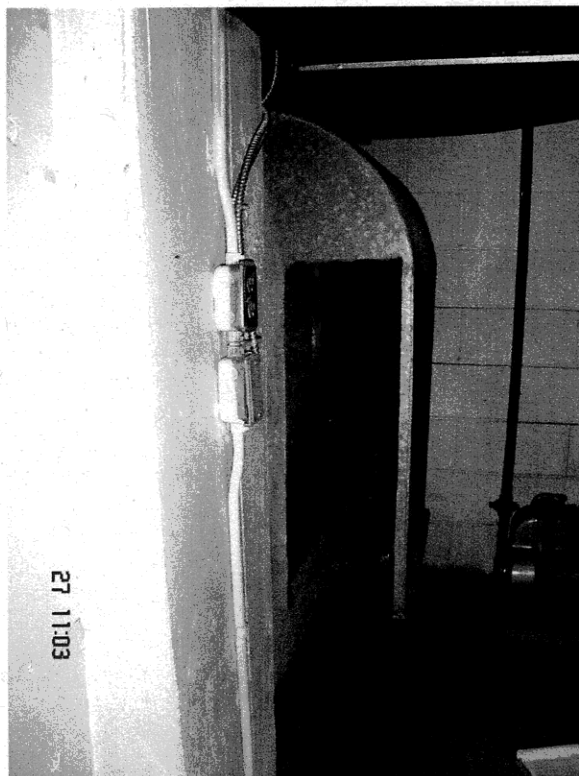
ductwork now violates the code: Natural Gas and Propane Installation Code (CAN/CSA-B149.1-05 Section 8.2.6 (a) (ii) The openings shall be as follows: be located not more than 18 in (450mm) or less than 6 in (150mm) above floor level. The combustion air duct should be retrofit to be code however if there has been a problem regarding combustion air further investigation should be done as this may be a safety issue.

Photo 9: Combustion Air

Cowling replaced in June of 2007.

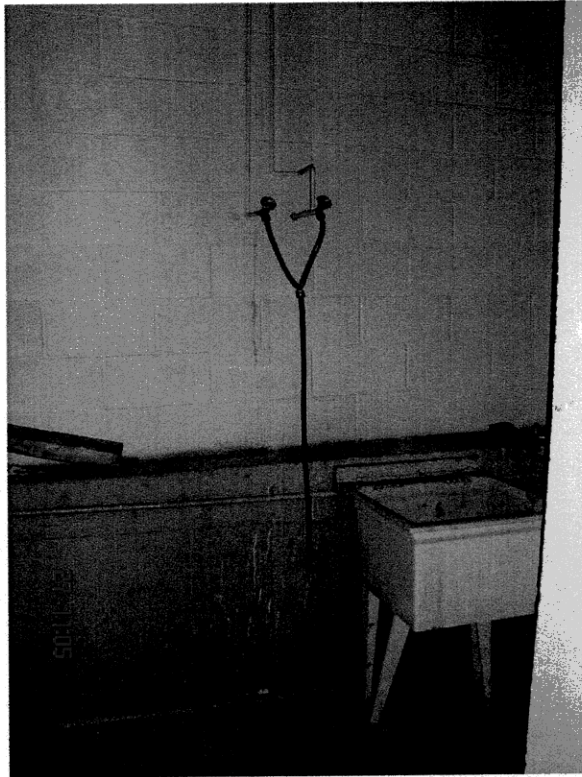
- Several locations (ceilings and walls) in the parkade and the lower level including the mechanical room and the sprinkler room have several openings that penetrate fire separations and are not properly sealed and therefore do not meet code. These openings and penetrations should be sealed as soon as possible. *Done.*
- The hot and cold taps (Photo 11) in the mechanical room and the exterior hose bib (Photo 12) require vacuum breakers to meet code. *all done.*

Photo 11: Hot and Cold Fitting

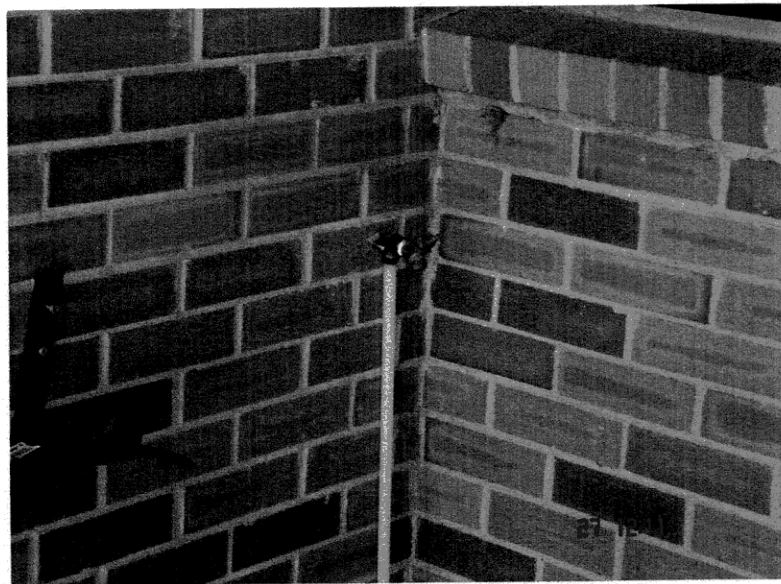
Photo 12: Exterior Hose Bibb

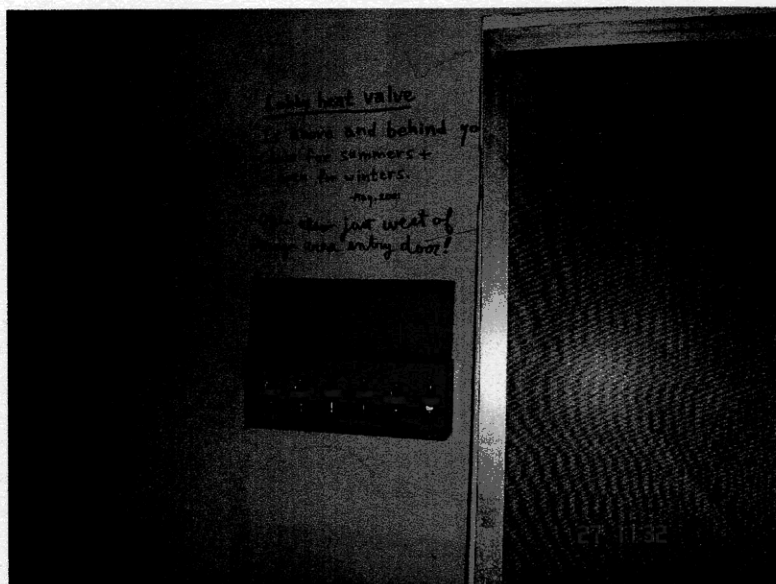
Six extra sprinkler heads (Photo 13) with a specialized sprinkler wrench are located in the sprinkler room. NFPA standards state a hydraulic design placard must be displayed on the sprinkler system riser.

Photo 13: Spare Sprinkler Heads.
