Reserve Fund Study

Condominium Corporation No. 9411439 Darlington Arms

Calgary Condominium Consulting Ltd.

Effective July 1, 2013, based on 2012 field inspections

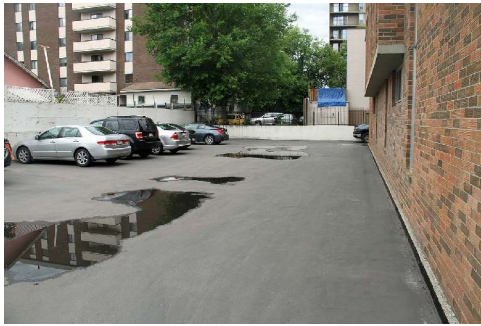
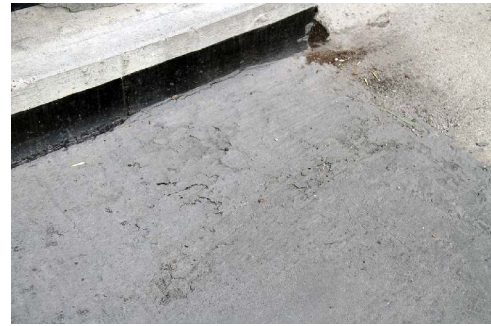
Surface parking on the south side of the complex is actually on the roof of an extended portion of the underground garage. Base on information from the contractor that did the last paving work, the concrete slab is believed to be protected by a bituminous membrane below the asphalt surface. Any repair of the asphalt must be done with this in mind. A yearly crack filling program will help to protect both asphalt and membrane.

The surface comprises **some 5,300 sq ft** and was reported to have been redone at the time of conversion of the building to condominium in 1998. A “seal coat” was applied in 2008 at an approximate cost of **\$2,550**. Some of the seal coat is flaking and it is recommended that yearly maintenance of the asphalt include cleaning and re-coating any such areas.

No signs of current leakage were noted on the underside of the slab and with maintenance, the surface should last another **11 years** on a revised **25 year cycle**. Current dollar cost to put a top lift on the pavement should be about **\$22,000**.

Note that a previous reserve study speculated that the weight of paving equipment used during the last paving job may have caused structural issues with the garage roof. It is strongly recommended that a second structural engineering opinion be sought as to the extent (if any) and potential seriousness of the damage.

Any future re-paving should be done with equipment not exceeding the weights recommended by such a structural engineer. Asphalt may have to be brought onto the slab by a small skid steer loader instead of dumped directly from trucks and it may be necessary to consider removal of some existing material at that time to keep overall weight within a safe range. A **year 1** allocation of **\$3,000** has been shown to fund a thorough inspection of the roof slab and support structure.

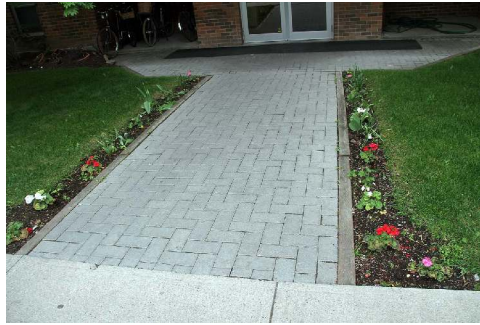
Nearly **300 sq ft** of paving stones provide a front-access walk to the building. The paving stones are serviceable and should be reset and replaced as needed from the maintenance funding **No separate funding** recommended at this time.

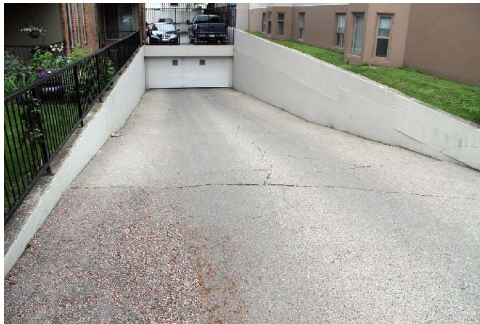
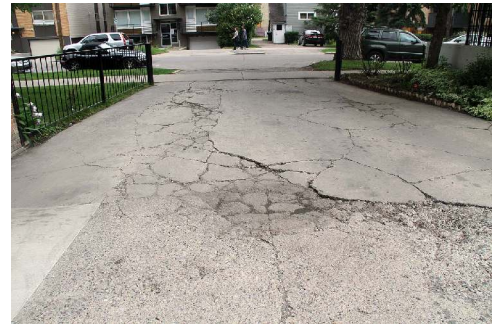
The underground garage is accessed by a ramp on the north west corner of the site and the surface parking by an on-grade concrete drive on the east side of the building. These are in very poor condition. As this is primarily a cosmetic problem, the timing and method of repair are a bit flexible. Total area is about **2,800 sq ft** and the cost to replace should be in the order of **\$40,000**. Allocate funds for the work in **year 1**.

Replacement concrete flatwork has currently been estimated to have a service life of from **20 years to life of the project**. Allocate funding for **15%** replacement of the new concrete in **year 21** and every **8th year** subsequent.

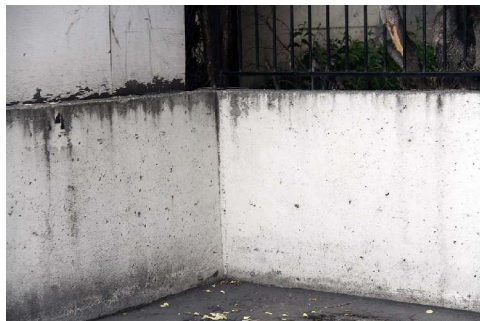
The east, south, and a large part of the west perimeter of Darlington Arms are defined by concrete retaining walls. Only the south side retains any significant loading and all of the walls appear to be straight and plumb. No significant cracking or displacement was seen. As they seem to have done well in **40 years plus** of service, at this point only continued monitoring of their condition has been recommended.

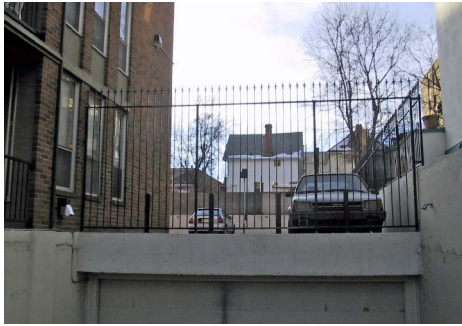
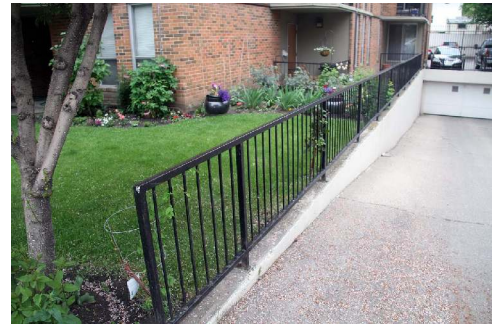
The Darlington Arms has **80 lin ft** of original style painted steel fencing on the east side of the garage driveway and on the west side of the surface parking driveway (the “Low Steel Fence”). It should last the economic life of the project, but occasional repair of post anchorage or other incidental damage is to be expected. Allocate **\$1,350** every **8th year** recurring in **year 5** for painting and general repairs. This allocation has been deemed to include painting and repairs to the surface parking gate. The gate operator has been dealt with in the mechanical section below.

In 2000 about **220 ft** of factory finished fencing was added to the east and west boundaries of the site (the “High Steel Fence”). It will require painting and repairs over the coming years, but painting may be deferred for a number of years. Allocate **\$2,800** for the maintenance of the east and west fence on an **8 year** cycle starting in **year 9**.

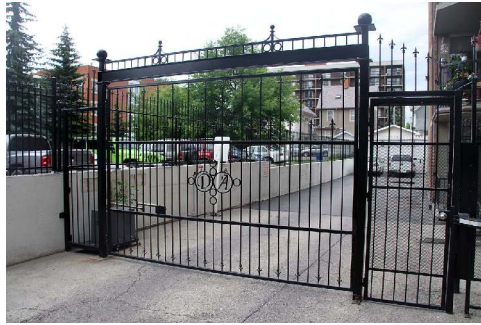
The surface parking area at the south end of the building is secured by a powered swinging steel gate. It was installed new in 2005 at an approximate total cost of **\$16,000** including a remote entry system. Allocate **\$2,500** every **6th year** starting in **year 2** for necessary repairs.

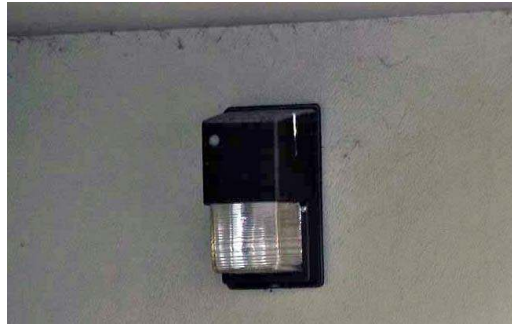
About **60** duplex outlets and a number of high intensity security lights are located on the balconies and around the perimeter of the building. Balcony lights appeared to be individual additions, improperly wired to the outlets below them. Weather-resistant covers were not present on any of the observed balcony locations. These should be installed immediately. This is handyman work that should be done from the yearly maintenance budget. Most of the outlets are located on well-sheltered balconies and replacements should last well.

The outlets and lights would currently cost in the order of **\$8,400** to replace. Allocate funds for **33%** replacement every **10th year** starting in **year 5**.

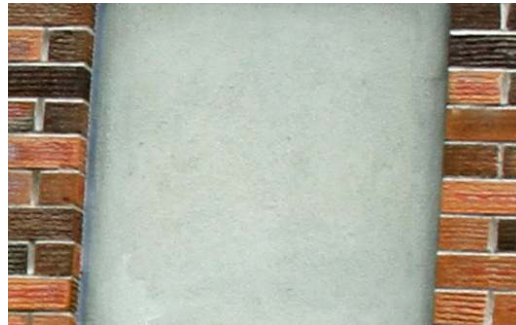
About **1,000 sq ft** of masonry stucco forms the outer siding below most of the windows on the building. To replace all these small areas of material would cost at least **\$28,000 in 2012 dollars**. With consistent maintenance, it should have an indefinite service life. It is suggested that a rigorous ongoing program of inspection and maintenance be carried on. Allocate **\$1,800** every **7th year** recurring in **year 5** for ongoing stucco inspection and repair.

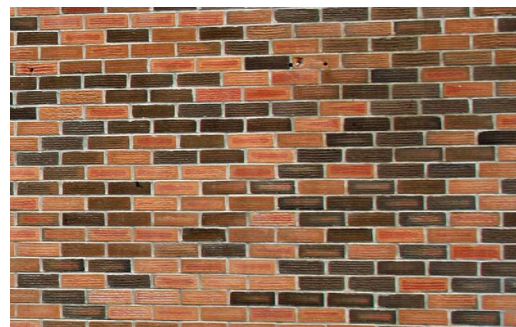
In the order of **15,000 sq ft** of brick veneer, worth in the order of **\$337,500** in current dollars, has been used as the main exterior cladding on the building. Some brick was replaced and general repairs done in 2007. It is the opinion of the author of this report that the brick has the potential to have an indefinite service life if it is adequately maintained over the coming years.

Allocate **\$12,000** every **8 years** recurring in **year 3** to inspect the brick and to repair and repoint as required. During the last reserve inspection of the building no problems were noted with the brick, but investigation of anchorage and control joints is beyond the scope of a reserve fund study.

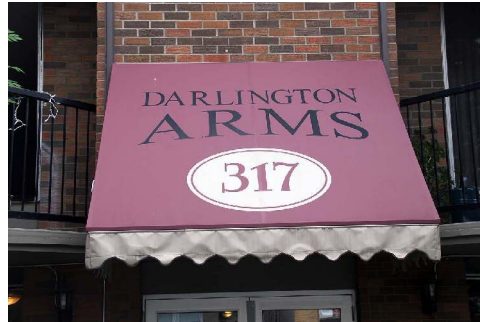
The front entry of the building features a small fabric canopy which is likely about **15 years** old. It appears to remain in very good condition, likely a result of the north exposure and limited direct sunlight on it. Replacement of the fabric would cost about **\$3,000** in current dollars and it should still last at least **7 years**. Fund for replacement in **year 8**. Steel framing for the canopy should only require periodic repainting (in conjunction with the steel fences), no separate budget suggested.

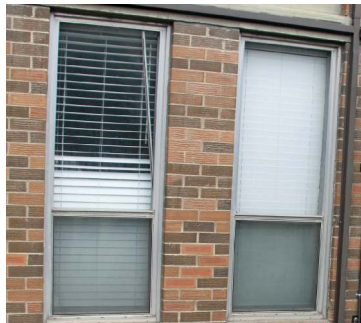
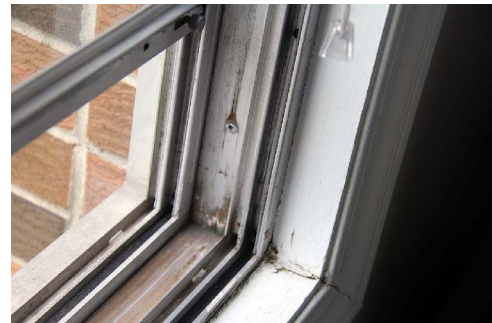
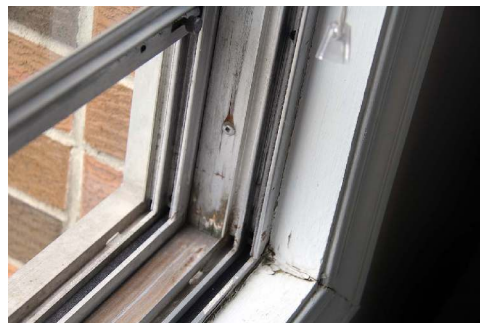
The site has nearly **165** casement multi-pane windows and fixed windows, **44** balcony doors, **65** common-area and unit-entry doors (interior), and a number of metal-clad and/or commercial-glassed exterior entry doors. Theoretical service life for the windows would be at least **45 years** and replacement cost in **2012 dollars** would be about **\$350,000**.

The current windows and sliding doors are neither attractive or particularly energy efficient, but they could remain in service for a long time to come. The corporation reimburses suite owners for needed repairs to windows and patio doors and has a written policy for sharing 50-50 the cost of discretionary replacements for owners who want them.

To date it has been reported that no owners have decided to make such replacements, but it is likely to happen at some point. If not the, full replacement by the corporation will have to be done over a period of time. Allocate funding for **20%** in **year 10** and every **5th year** subsequent. It has been assumed that track and roller repair as needed on the sliding doors and weatherstripping and hardware repair as needed on the windows would be paid from operating funds.

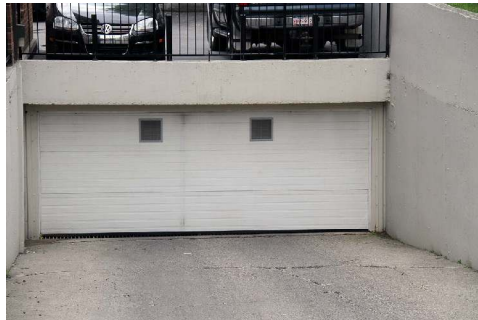
The underground parking garage is accessed via an overhead door employing an electric lift with a keyed entry system. The door and lift was replaced in 2009 at a cost of **\$4,900** and is expected to last up to **20 years** with good maintenance. The 2012 cost of the door would be in the order of **\$5,500** and the next replacement is shown in **year 17**.

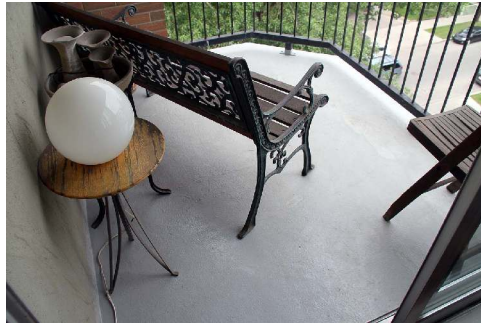
Darlington Arms has pre-finished metal railings on the balconies. This material should last the life of the project, but surface oxidation of the finish makes periodic repainting a good choice. At the date of the last field inspection a lot of surface deterioration was seen. Balcony rail painting can be expensive due to the need to either access them through units or set up staging for exterior access. Allocate **\$9,500** every **8th year** starting in **year 1** to prepare and paint the balcony rails.

The balcony decks appear to be un-coated concrete. It is recommended that the group consider having a pedestrian-grade urethane coating (or equivalent) applied to extend the life of the concrete. As this would be an improvement, no funding has been shown in the reserve study.

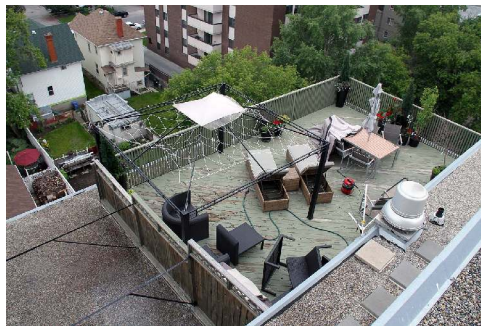
About **1,500 sq ft** of the roof of the 7th floor is used for two exclusive-use decks. These are built over the tar and gravel roof with deck boards fastened to wood sleepers on top of the roof membrane. It is reported that all costs associated with them are deemed to be unit owner responsibility, no reserve funding has been shown.

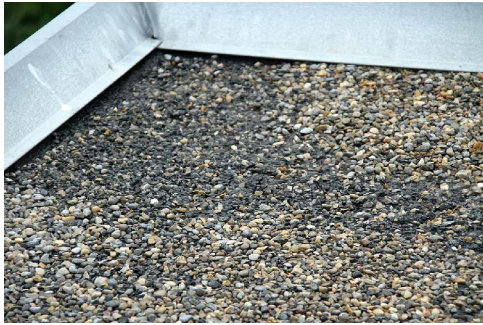
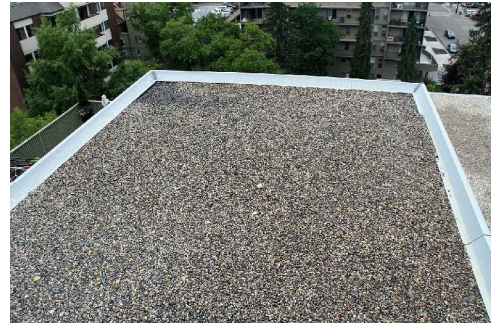
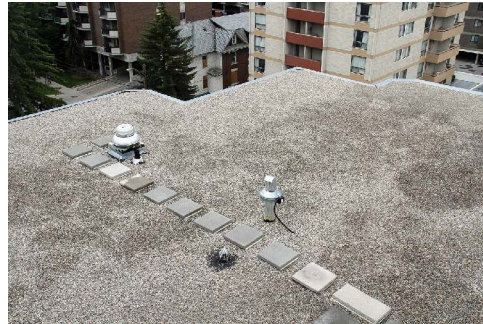
The Darlington Arms has a multi-level flat roof covered by a conventional built-up tar and gravel membrane totaling some **5000 sq ft**. It would have had an original **20 year** life expectancy, and was reported to have been replaced at the time of conversion in 1998. The board has commissioned a lot of maintenance work on the roof and it has been taken to be effectively **12 years** old. Current cost to replace with a similar membrane should be about **\$95,000** and replacement has been shown in **year 9**.

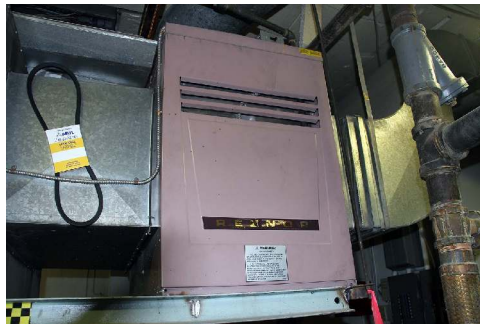
A gas-fired corridor pressurisation furnace is employed in the complex. It should have a service life of **25 to 30 years** and would cost **\$25,000** to replace today. The fan and filter stage appeared to be originals coupled to a newer Reznor single-stage indirect fired furnace. Replacement projected for **year 6**.

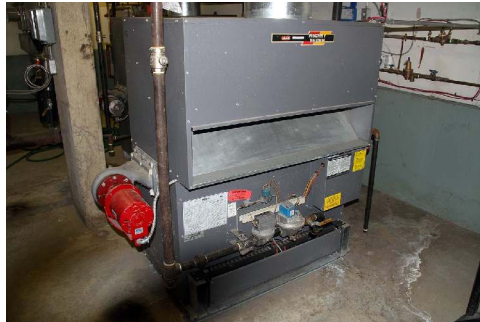
An original boiler with cast iron heat exchanger was replaced in 2002 with two new Laars Teledyne packaged boilers (model PH 0715 IN 1 K 1 C C TC units) with indoor/outdoor controllers, micron filter and chemical feed pot. They now provide hot water for the hydronic heating system in the building. They should have a service life of **30 to 35 years** and will cost in the order of **\$17,500** each in current dollars to replace.

It should be noted that they are standard-efficiency boilers which are not likely to be available by the time the next replacement is needed. Condensing boilers or some future improvement on them will be the likely more energy-efficient type available and they will be relatively more expensive. Replacement funding of **\$45,000** has been shown in **year 25** in the expectation that the higher-efficiency units will be the only type available.

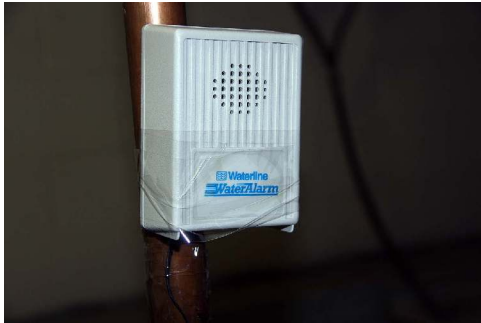
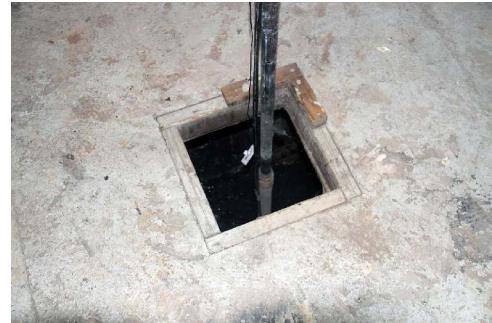
One sump pump was observed in a pit in the floor of the mechanical room. It was not accessible for close-up examination, but has been replaced in the past **10 years** and has a high-water alarm system attached to it. Allocate **\$1,250** for replacement in **year 6** on a **15 year cycle**.

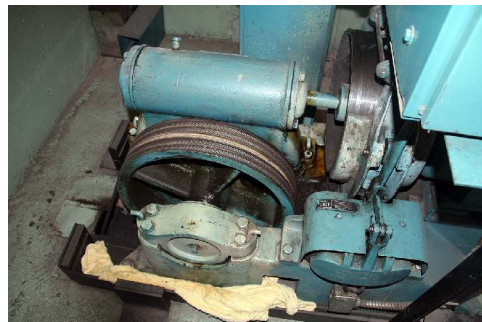
Darlington Arms is served with an original Turnbull elevator with relay controls. Elevators in this type of building are used on a very low-duty cycle, and with the exception of decor items in the car, should last for **45 or more years**. Many are replaced due to perceived lack of parts availability, but the service contractor for Darlington Arms has apparently been able to access hard-to-get items over the internet. There is no way to determine how long this will stay possible and it is only prudent to plan for the need to replace and hope to defer the timing.

Elevator replacement in similar buildings has been running in the order of **\$175,000** or more and replacement is projected for **year 8**. It should be noted that because of code requirements it is nearly impossible to do partial updates to the elevators without close to complete replacement, but replacement of parts is fine. If parts can be sourced and service is satisfactory, continue to defer replacement.
