Darlington Arms Condominiums

Reserve Fund Plan

Following up on the reserve fund study by
Morrison Hershfield Engineering, February 2007

4. OBSERVATIONS AND RECOMMENDATIONS

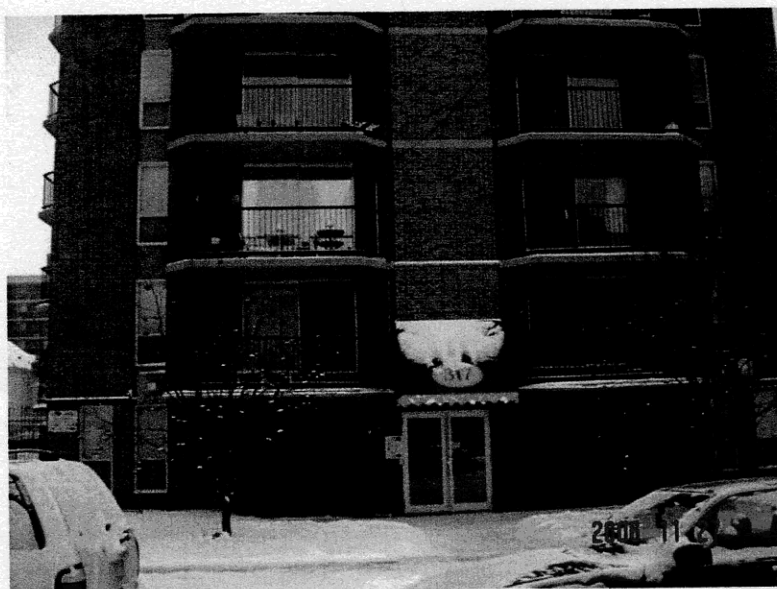
The condominium complex (Photo 1) is comprised of one building with an aggregate total of 40 suites. It is our understanding that the building is approximately 38 years old. The complex has two entrances, one facing 14th Avenue SW and the second located at the east side of the building. The complex is primarily brick faced and is surrounded by a metal fence. An automatic access gate is located on the east side of the complex with under ground parking access located on the west side.

Photo 1: Darlington Arms Condominium Complex.

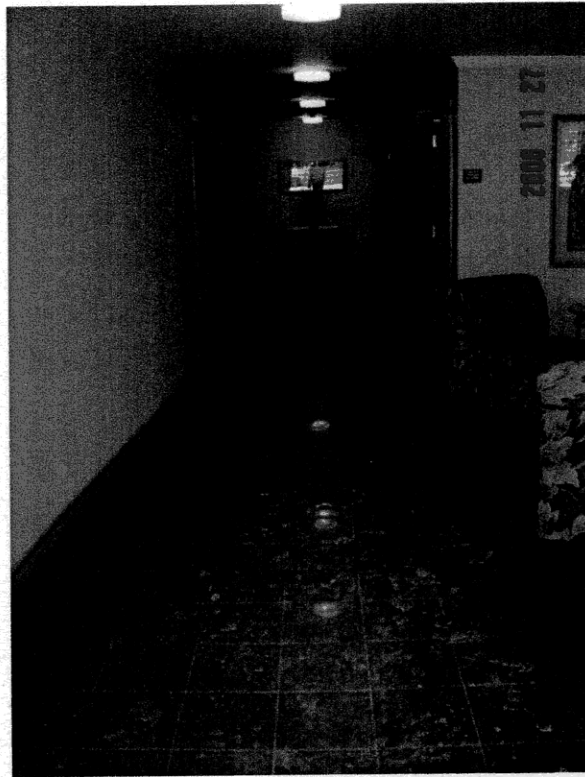
The main lobby (Photo 7) was finished with tiled flooring, painted walls, and a painted ceiling. The tile appeared to be in good condition while the wall coverings and ceiling appeared to be in fair condition.

Photo 7: Main Entrance
