Reserve Fund Study

Condominium Corporation No. 9411439 Darlington Arms

Calgary Condominium Consulting Ltd.

Effective July 1, 2013, based on 2012 field inspections

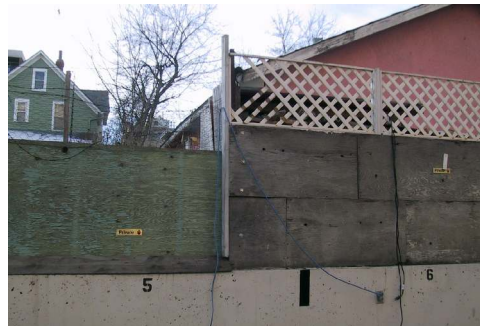
A high concrete wall on the south end of the site has lattice work and other odd bits of fencing on top, all of which are assumed to be the property of the neighbors.

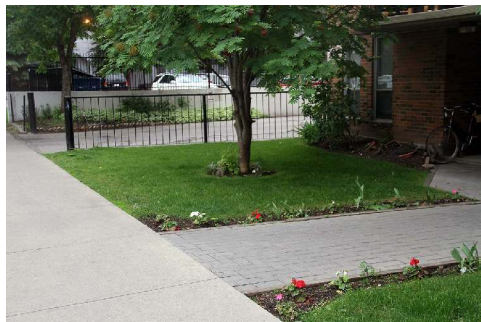
The site is planted with very limited grassed areas and trees. These do not have a specific service life, and can last indefinitely with good care. Some costs will be incurred on a non-annual basis and a landscaping fund of **\$1,200** every **5th year** recurring in **year 3** has been recommended

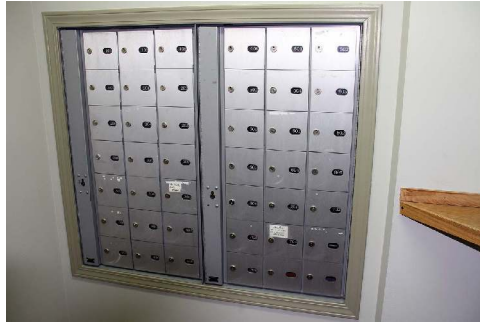
A mailbox is located in the entry lobby of the building. With ongoing repair and service, it should have an indefinite service life. Locks, hinges, etc. should be replaced as they wear out and no separate funding is shown for replacement.

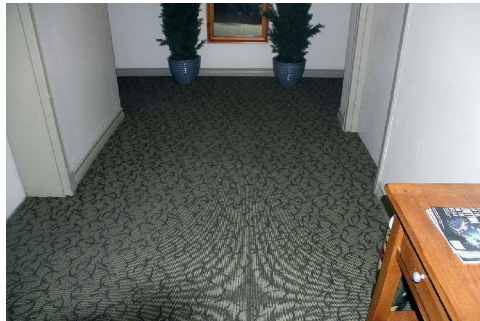
The bulk of the flooring material in the building is commercial carpet. It amounts to over **200 sq yds** and was replaced in 2008 at a cost of about **\$16,600** to replace today;

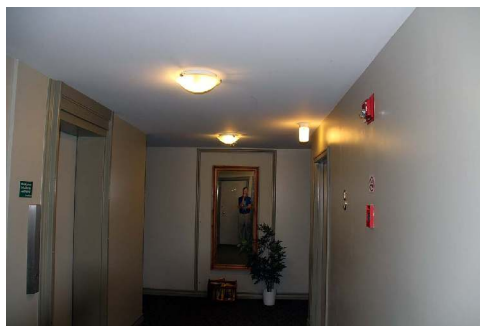
Common area ceilings in Darlington Arms are painted drywall and should not need very frequent painting;

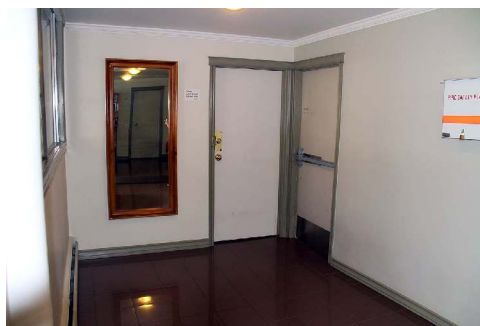
Interior door paint appeared to remain in good condition;

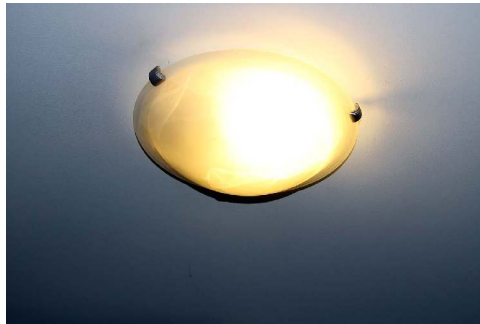
Lighting for the common areas includes; 60 low-wattage fluorescent ceiling fixtures, seven sets of two-tube four-foot-long florescent fixtures, and 15 general-purpose lights. Lighting in the lower lobby was improved in 2007. Garage and entry lights were replaced circa 2008 with energy-efficient t8 fixtures at a cost of about **\$7,600**;

The exit lights appear to be fully functional originals. LED units are strongly recommended for all future replacements. Although more expensive to buy, they have a much longer service life and take about 1/7 the energy of a regular bulb;

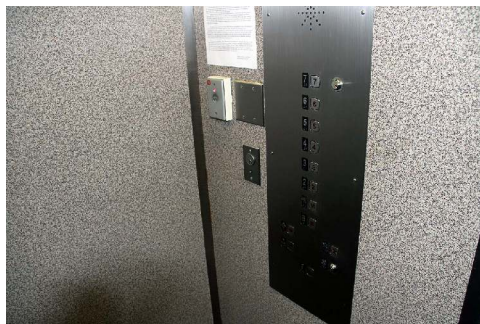
Decor in elevator cars dates with time and over the years 2002, 2004 and 2005 it was upgraded at Darlington Arms. This approach of staged changes is not very common, but appears to work very well at the subject property;

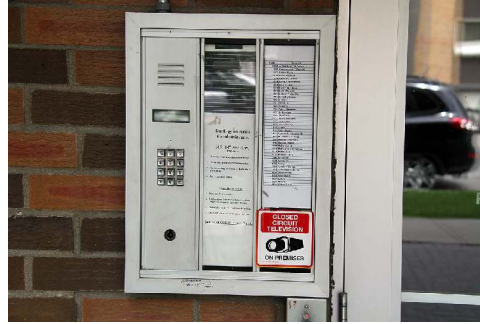
A telephone-integrated intercom system is employed to provide guest access through the front entry of the building. It should have a **35 year** life and would currently cost about **\$4,250** to replace. Remaining life has been projected to be **21 years**.

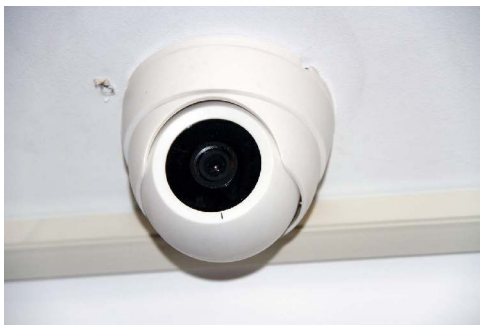
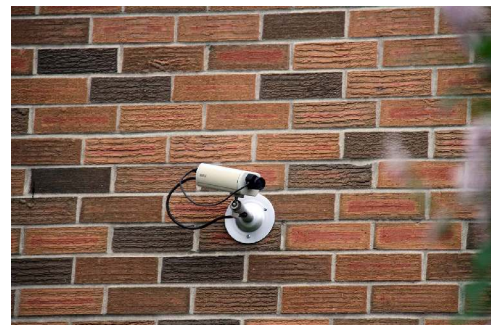
4 CCTV cameras, a lobby-based “proof you’re on TV” monitor and a DVR were installed in the building circa 2005 at an approximate cost of **\$9,000**. Such equipment is evolving very quickly and tends to be replaced periodically. Allocate **\$5,000** for partial replacement of the system in **year 4** and every **10th year** subsequent

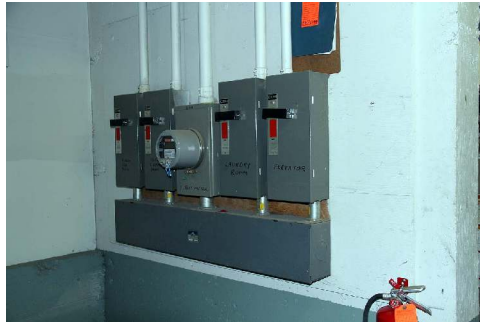
The main electrical service and panels for the building should last the economic life of the project. No budget is suggested, but a qualified commercial electrician should be checking main connections for tightness on a regular basis. It is also recommended that the corporation commission periodic thermal scans of all accessible electrical devices and conductor to check for high resistance areas that could lead to damage or even fires.

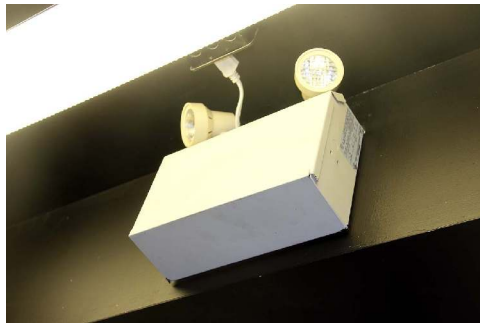
The building incorporates emergency lights that are battery operated. Lights were added to supplement the service provided by an emergency generator system in the building and all should be serviceable for the foreseeable future. They are reportedly inspected quarterly and battery replacements as required plus other parts treated as an operating expense.

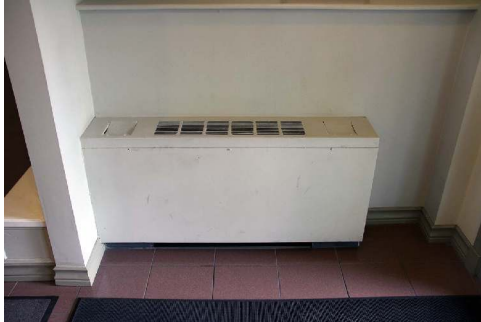
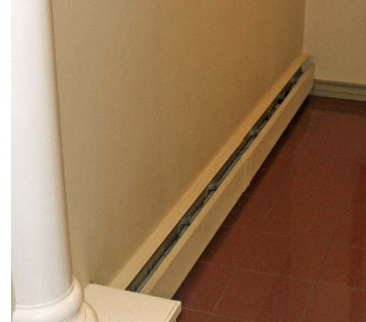
The entries and service area in the building are heated by a combination of fan cabinet and baseboard convector units. They are simple and generally very long lasting but it has been deemed prudent to include a major repair fund for them. Allocate **\$2,500** every **8th year** starting in **year 4** for common area convector major repairs

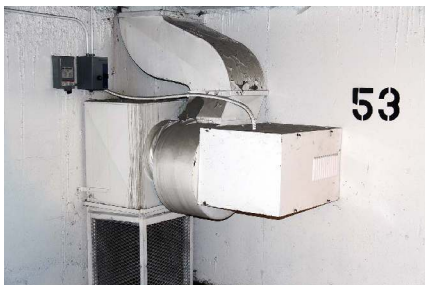
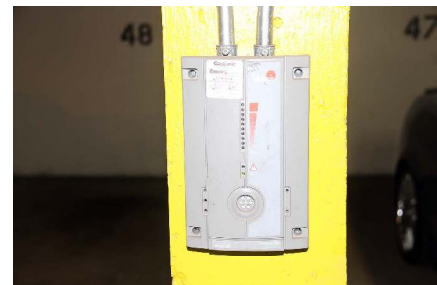
Fans consist of a minimal number of parts (i.e. motor, belt, shaft, some type of rotor and the housing) and generally may be rebuilt on an economical basis almost indefinitely. CO detectors require regular testing and re-calibration (an operating rather than reserve cost) and replacement at irregular intervals. A rebuilt and replacement fund of **\$2,500** every **8th year** starting in **year 5** has been shown for this purpose. Review for adequacy at each update of this report.

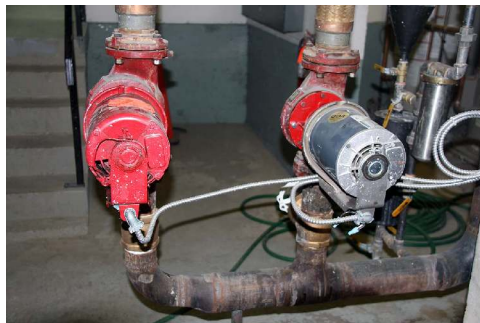
Redundant heavy-duty pumps (Bell and Gossett) are employed to circulate the water through the building heating system. Current practice with this type of pump is multiple rebuilds and they are seldom completely replaced. Allocate **\$900** every **6th year** starting in **year 2** for pump rebuilding.

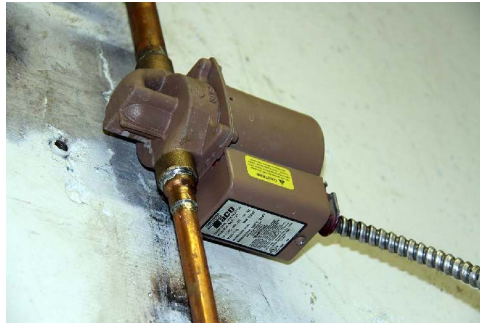
A fractional-horsepower Taco 006-BCF-IFC pump has been employed to circulate domestic hot water to the apartments. These have a typical life expectancy of around **9 years**, but can be run to failure with no real problem for the building. Allocate **\$1,050** for an equivalent pump in **year 5**.

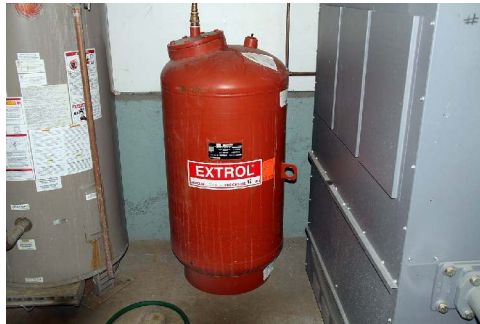
An Extrol high-pressure diaphragm type expansion tank has been installed in the boiler room since we last viewed it, most likely at the time the new boilers went in. Remaining life is taken as **10 years** on a replacement **20 life cycle**. Replacement cost will be the order of **\$2,600**.

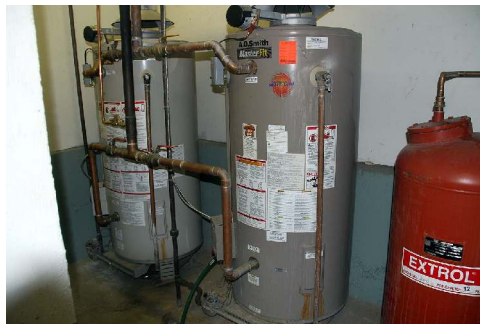
Two power-vented 65 US gallon A O Smith hot water tanks with spark ignition are providing domestic hot water to the building. They were reportedly installed in 2002 and 2003, putting them near the end of a current typical service life expectancy. Allocate **\$6,750** to replace one in **year 1** and one in **year 2**. Note that the tanks can be run to failure with no likely down side, sometimes well beyond the **9 year** life we see with the majority of the newer tanks.

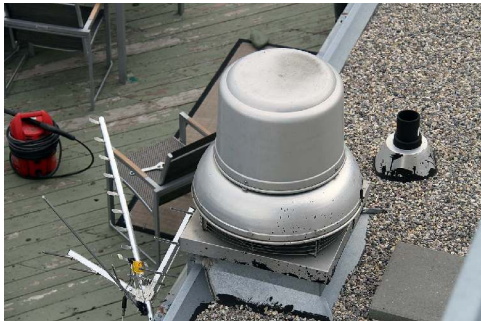
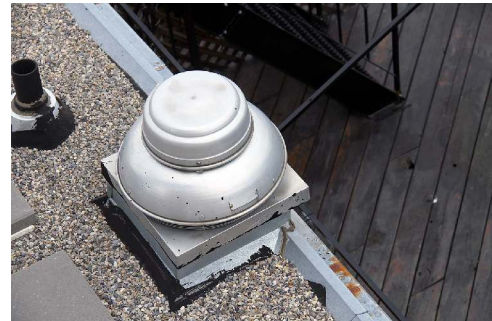
The building has a number of axial-vane exhaust fans on the roof, mostly fairly recent replacements. They are simple and quite durable in most applications and an allocation of **\$750** has been shown on a **5 year** cycle starting in **year 5** for periodic replacements as required.
